TITAN ENGINEERING CONSULTANTS, LLC

**TO: City of Austin
Building Inspection Office**

**RE: Engineer's Completion Certification of Foundation Repairs
@ 1700 JJ Seabrook--Austin, Texas**
Ref.A) Mendoza plan of repairs

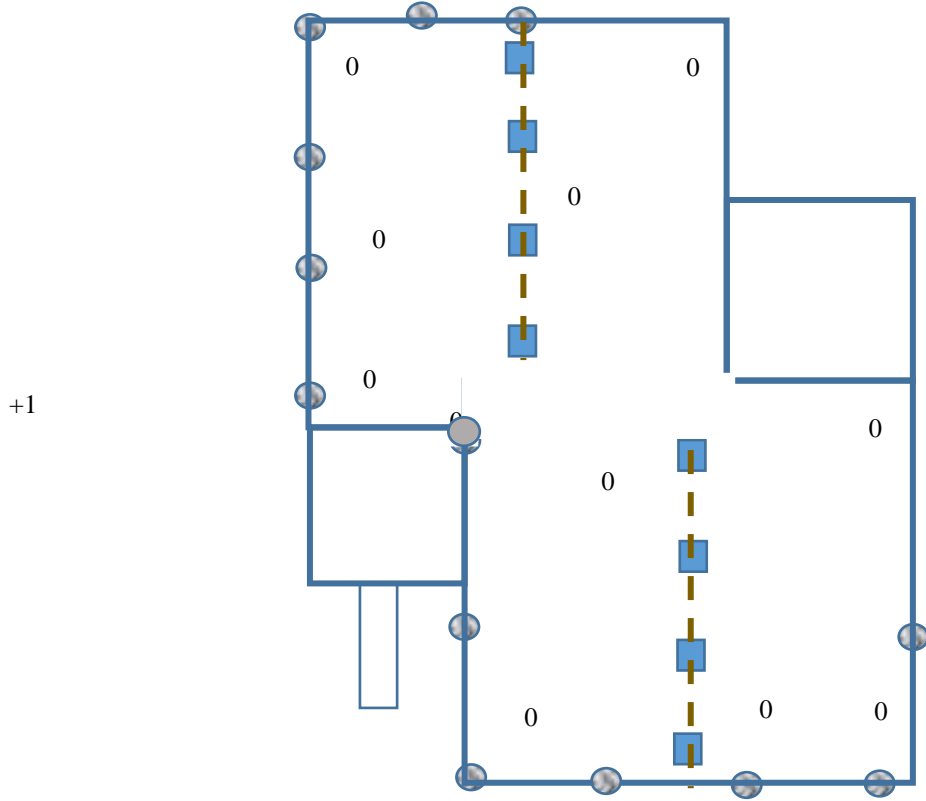
**AS BUILT FOUNDATION REPAIRS
FOR
1700 JJ Seabrook
Austin, TX 78721**

The contractor installed 8 spread footings beneath 42 linear feet of new 4"X6" timber beams. Spread footings were each composed of a minimum twenty-four inch square by ten-inch thick reinforced concrete footing installed twenty-four inches below grade.

The contractor installed piers composed of segmental concrete pilings along and under 13 perimeter areas in locations shown on the attached Mendoza plan of repairs.

The floor area of the house was adjusted to a reasonable level position. The contractor complete backfilling and cleaned up the work area
